Wood Floor Restoration Summary
Patterson House – Washington, DC
Summer 2006

Rosebud Co.
Atlanta, Ga.

Overview and Explanation

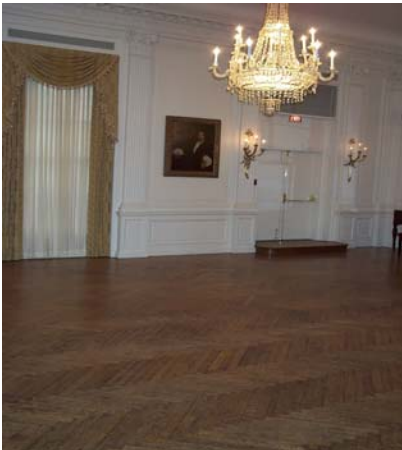
The primary concern in the ballroom area was the overall condition of the floors and their appearance. Due to their age, the floors had experienced multiple sanding and substantial loss of original material. The erosion of the wood was exacerbated due the herringbone pattern. Due to this pattern

much of the sanding of the floors would have been against the grain of the wood and this would have accelerated the loss of the oak flooring. It would be safe to say the floors had been sanded a minimum of three to four times during its history and the amount of wood lost was beginning to show in structural failure along the tongue and groove of the wood. The wood was too thin to adequately support weight and was fracturing or shearing along the parallel seams of the wood.

The appearance of the floors had deteriorated primarily due to the finishes and maintenance products that had been applied to the surface over the years in an attempt to improve and protect the service. The excessive amounts of products were obscuring the color and clarity of the wood. This was further compounded by the discoloration of the finish. It had turned a dull grey and diminished the natural beauty of the wood.

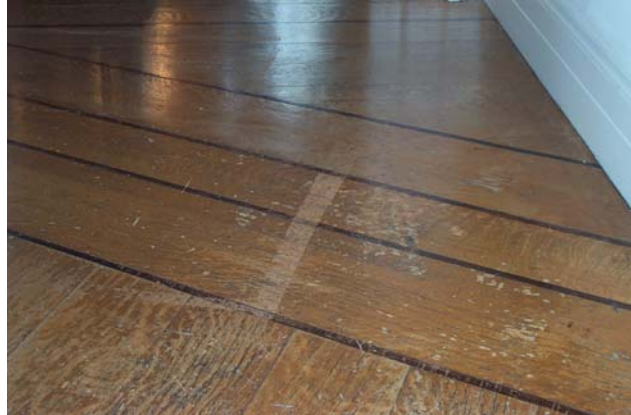
During the visit, attention was also focused on the second floor foyer and the Patterson Dining Room. Of particular concern in the foyer was the damage that had occurred from caterers by applying adhesive tape to the older finish. When the tape was removed, layers of old finish were pulled up leaving clear and visible evidence of the damage.

This damage was not only visible but also added one more distraction to a floor that had been intended to be a beautiful and decorative background and compliment the interior décor of this magnificent home.

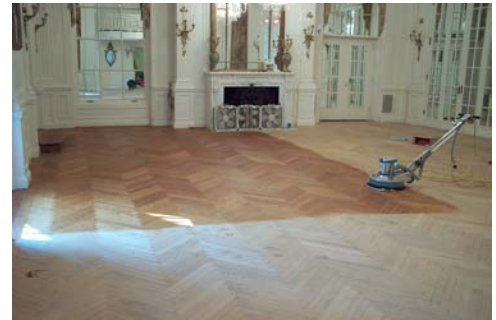
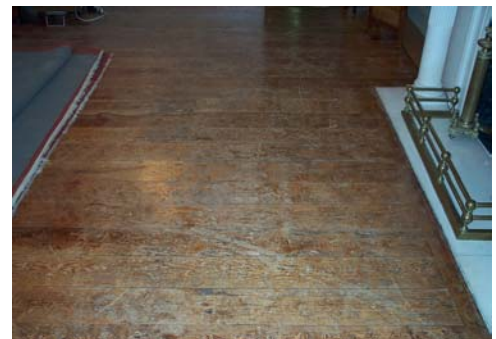
Before pictures of the pine floors in the Patterson Dining Room. Note lack of color and definition of distinguishing graining pattern.

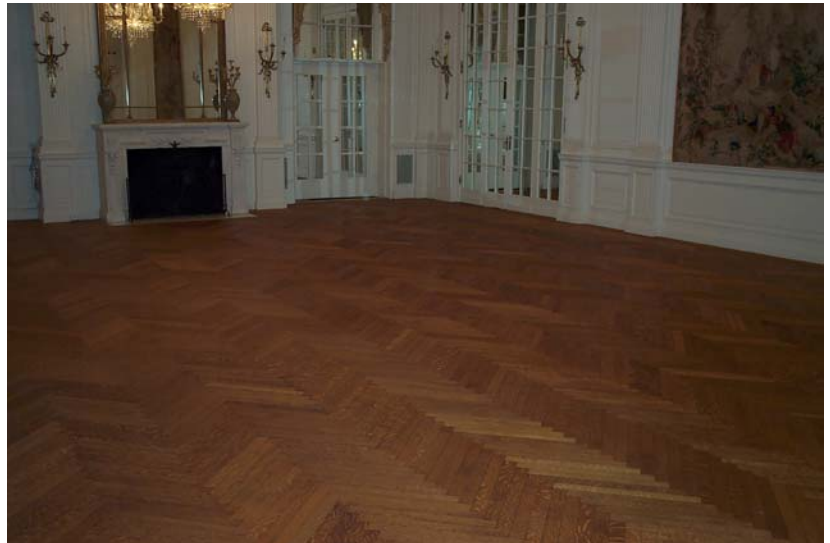
In this photo we see the ballroom floor after the restoration work was completed. The two photos here, the before and after, have not been altered in any way. The color tones of the 104 year old oak floors are the color achieved from aging. The rich color tones achieved here are the result of the wood making contact with an oil product.

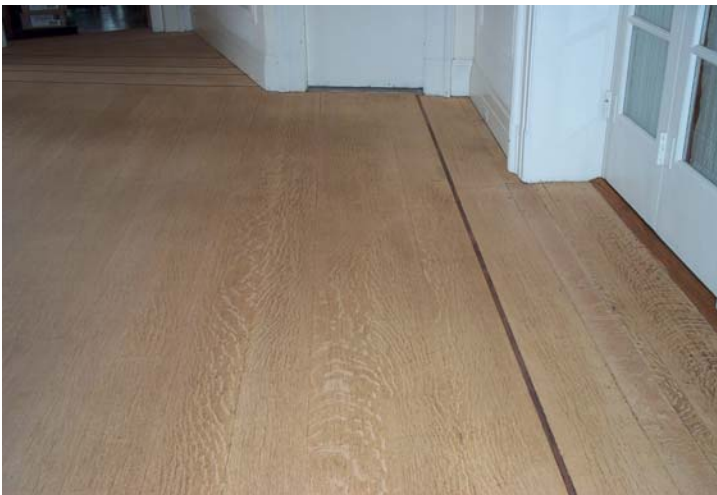
This third photo in the series shows the finish with all of the old finishes removed. Note that all the color variations in the old finish were not found in the wood. After the Trip Trap finish was applied, there were no visible traces of original discolorations.

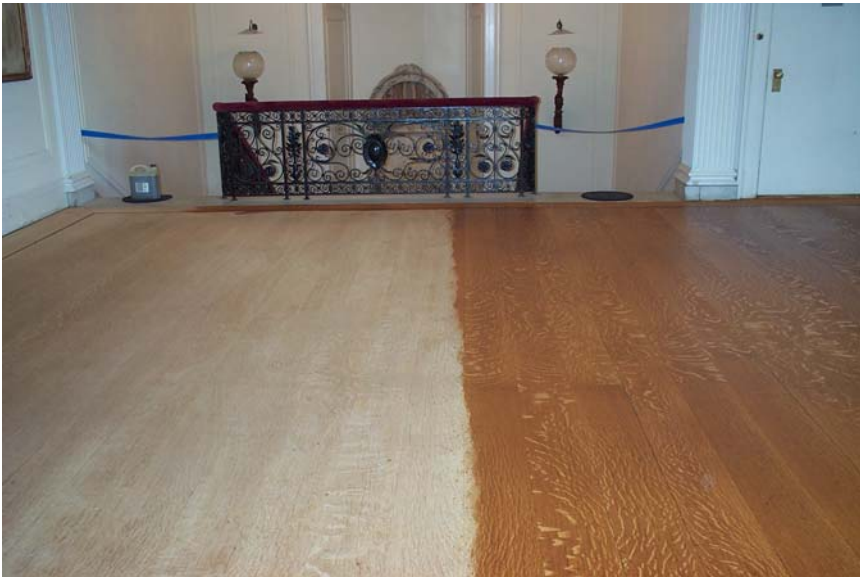
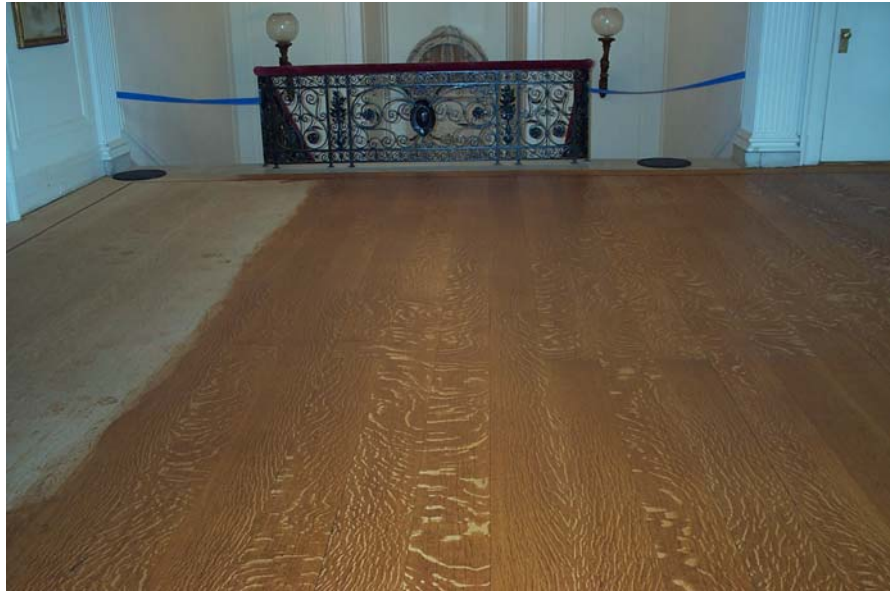
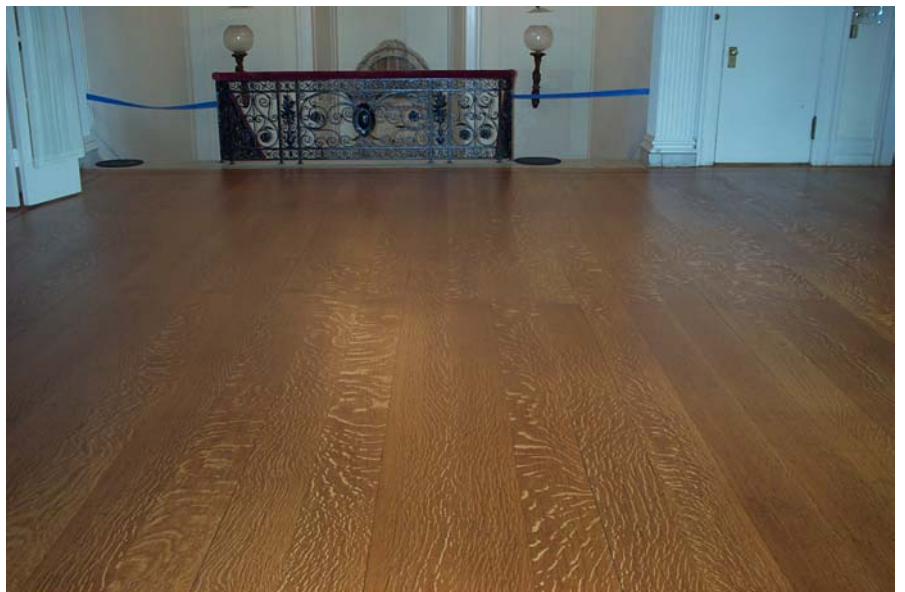
In this series of photos we see the progression of the finish as it is applied to the foyer floors. Please note the uniformity of color and the lack of distortion that was in the original finish prior to its removal.
