## **Blending History on Virginia's Eastern Shore**

*Caserta*

**June 2008  
Rosebud Co.  
Atlanta, GA.**

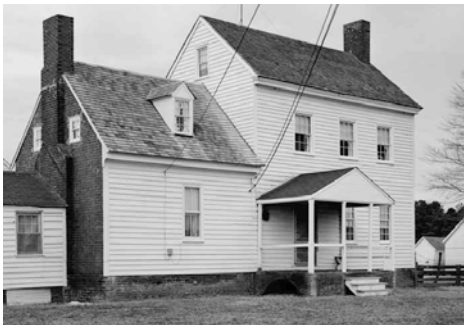
two older farmhouses located at different locations on the East Shore. The larger of the two was known as Runnymede and its original location was around Accomack, VA. The smaller section of the house pictured to the left had a brick dated to 1797 and the larger section dates to 1862. The two sections were pulled apart and now provide

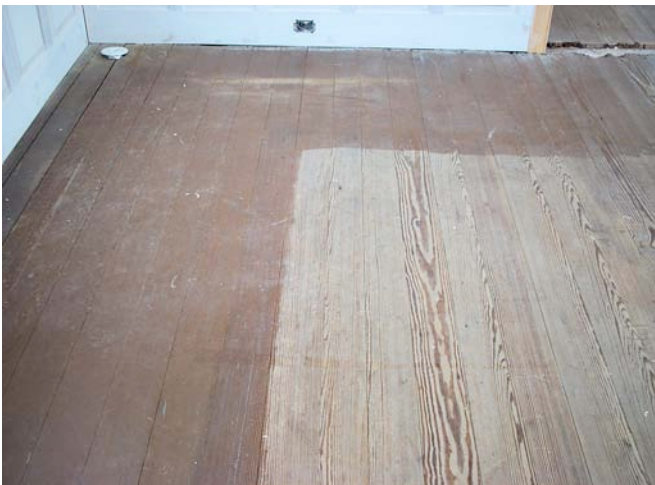
In this photo of the living room floors you see the pattern of paint around some floor covering. Based on the popular trends of that time, it is safe to assume that a floor cloth or area rug sat in the middle of the room and that paints were applied around the perimeter

In the living room, not only is the paint gone but so is any trace of a shadow from where the paint had been applied.

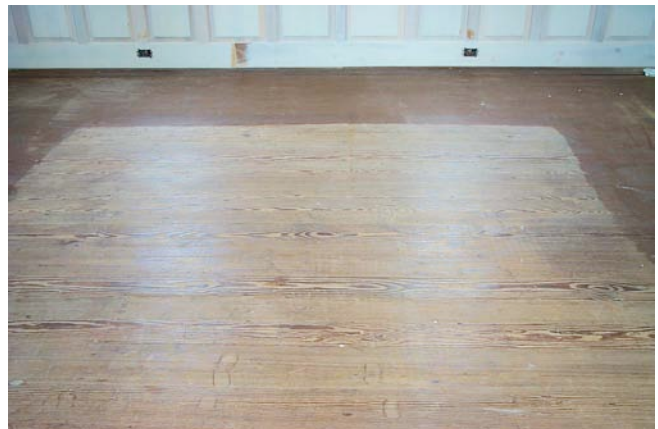
Same floor, different view. The clear area in the middle often appeared like it had never had any finish but we often encountered light accumulations of old drying oils.

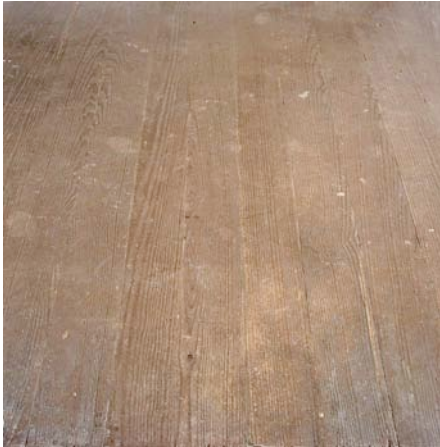
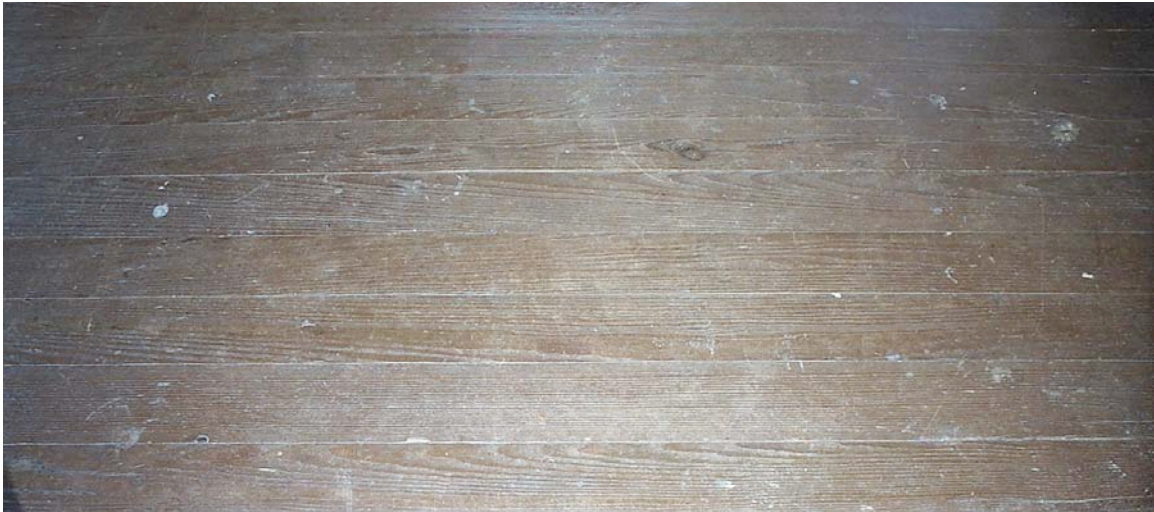
Other rooms were painted entirely. To the left is a portion of the central “cross hall” and it had a mustard/brown paint. The second picture was shot from the front porch area looking towards the rear of the house. In both cases, note the level of accumulation of paint on the floors. It is impossible to see the wood due to the thickness of the paint.

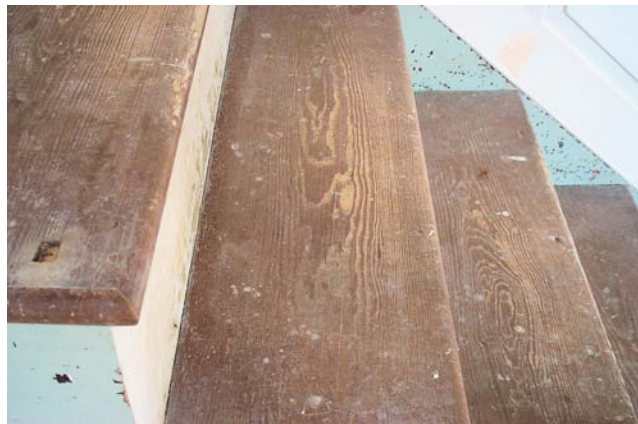
The central stairs show the wear pattern from the foot traffic. The paint has been worn through to expose the grain pattern.

The stairs have a uniform rich color. All wear patterns are gone.

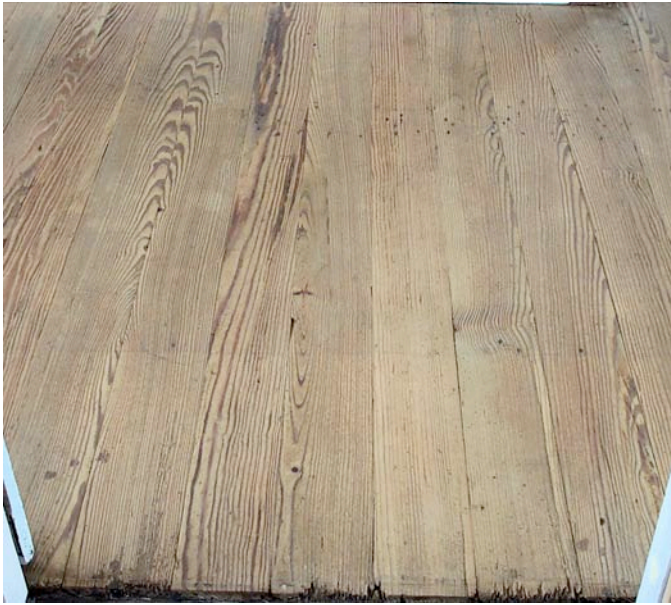
As the paint is removed and the old wood cleaned, the aged character of the yellow pine begins to emerge. The surface accumulations were numerous and thick so multiple applications of the cleaner were applied to get the desired results.

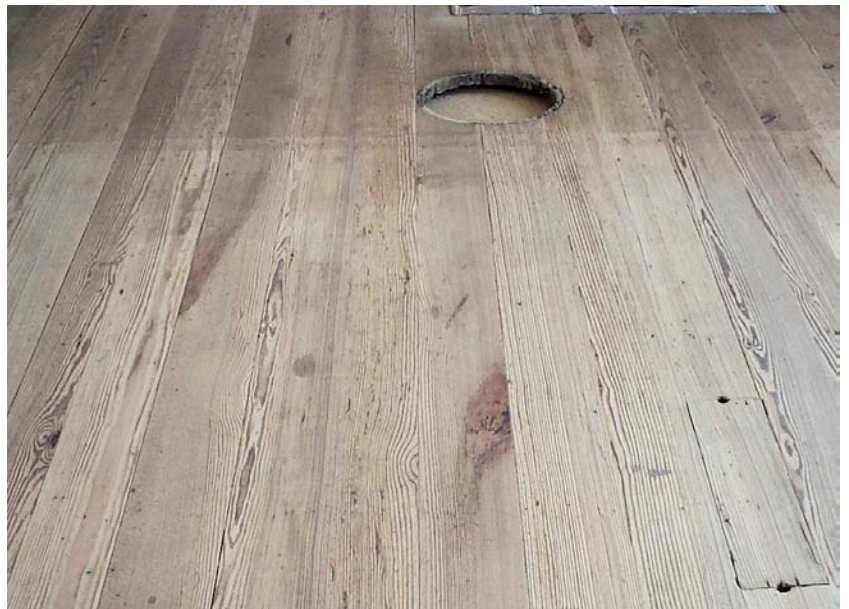
The rich colors of the aged pine are clearly visible in the central hall.

In a second floor bedroom, we see the cleaned wood as well as a shadow in the upper portion. The shadow, a darker line that goes from side to side just below the round hole, is where paint had been applied. The color variation indicates different aging rates of the wood due to the paint on the surface.

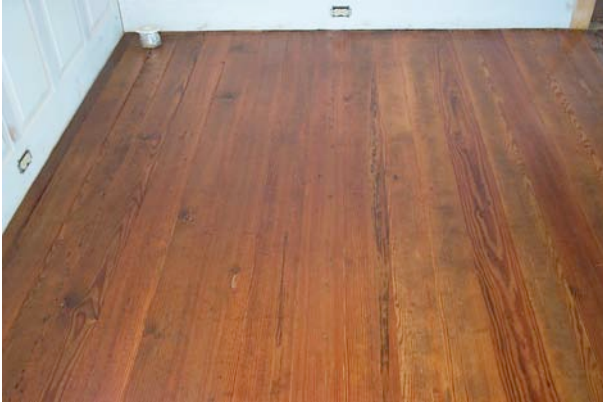
The application of the oils to the aged wood brought about significant color changes in the floor.

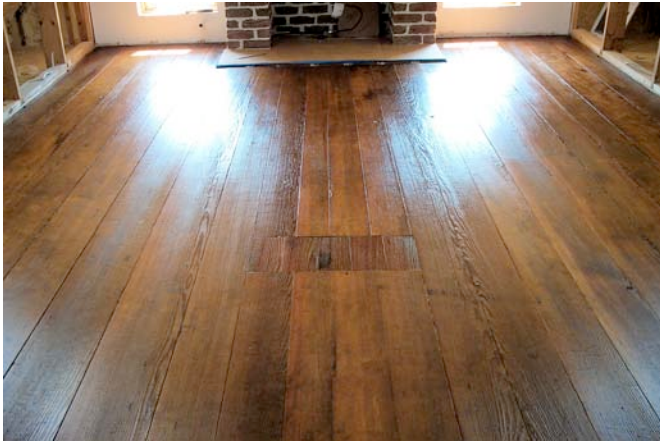
In the second floor bedroom, all traces of shadows are gone. The round hole in the floor was a gravity fed heat vent allowing warm air to flow upstairs from the first floor area.

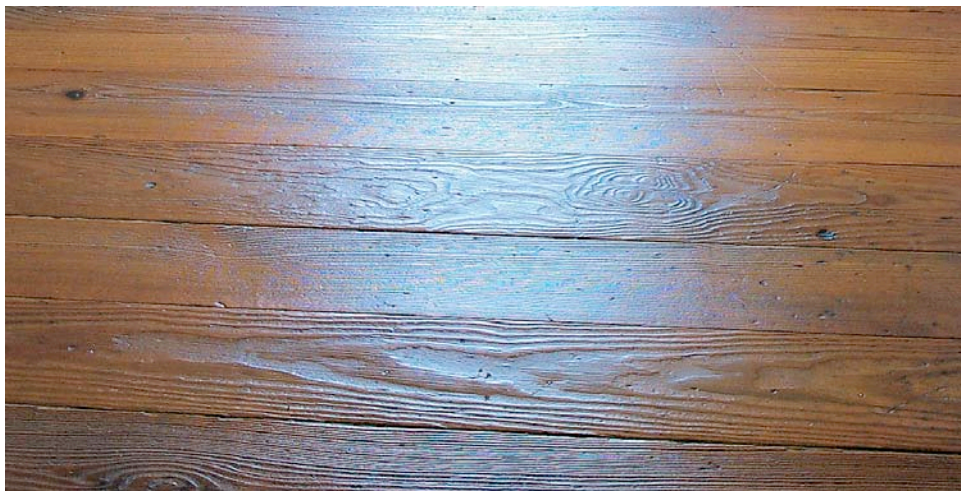
The second floor sewing room now displays a level of color and warmth in aged pine that is rarely seen. There was no color added to the oil applied to the floor

Passive Refinishing also reveals another unique feature when the finish oils are applied. The raised grain of the wood is visible and highlighted in the photo to the right and below. Small holes from tacks no longer are an annoyance but a decorative feature of the wood. These unique qualities would have been lost with traditional sanding.
