Wood Floor Restoration Summary
Patterson House – Washington, DC
Summer 2006

Rosebud Co.
Atlanta, Ga.

Overview and Explanation

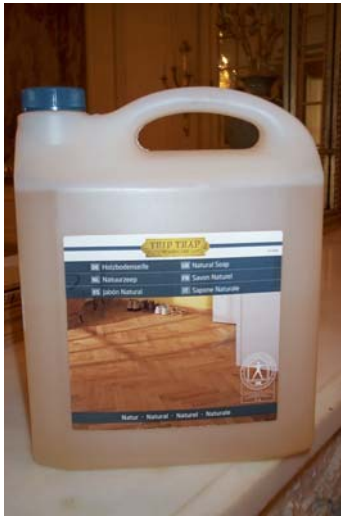
maintenance. The selection of an oil product eliminated the possibility of future damage comparable to the damage experienced from the application of tape to

hold materials and objects in place. This had resulted in damage to the finish that the members found highly objectionable. The lack of film formation that would have occurred had a finish been applied to the floors minimized the possibility of this recurring. Furthermore, the maintenance of the Trip Trap products involved mopping to clean off food and beverage from banquets and actually helped replenish the oil in the cleaning process. The cleaning solution for the floors contains small amounts of oil that were deposited on the surface

(It should be pointed out that the selection of finishes was based upon current and future use of the floors as well as an eye toward their continued
